# Delimitation of the Watershed Tributary to the delimited Habitat of the Coquí Llanero, Sabana Seca, PR

## Delimitation of the Watershed Tributary to the Delimited Habitat of the Coquí Llanero Sabana Seca, PR

July 6, 2007

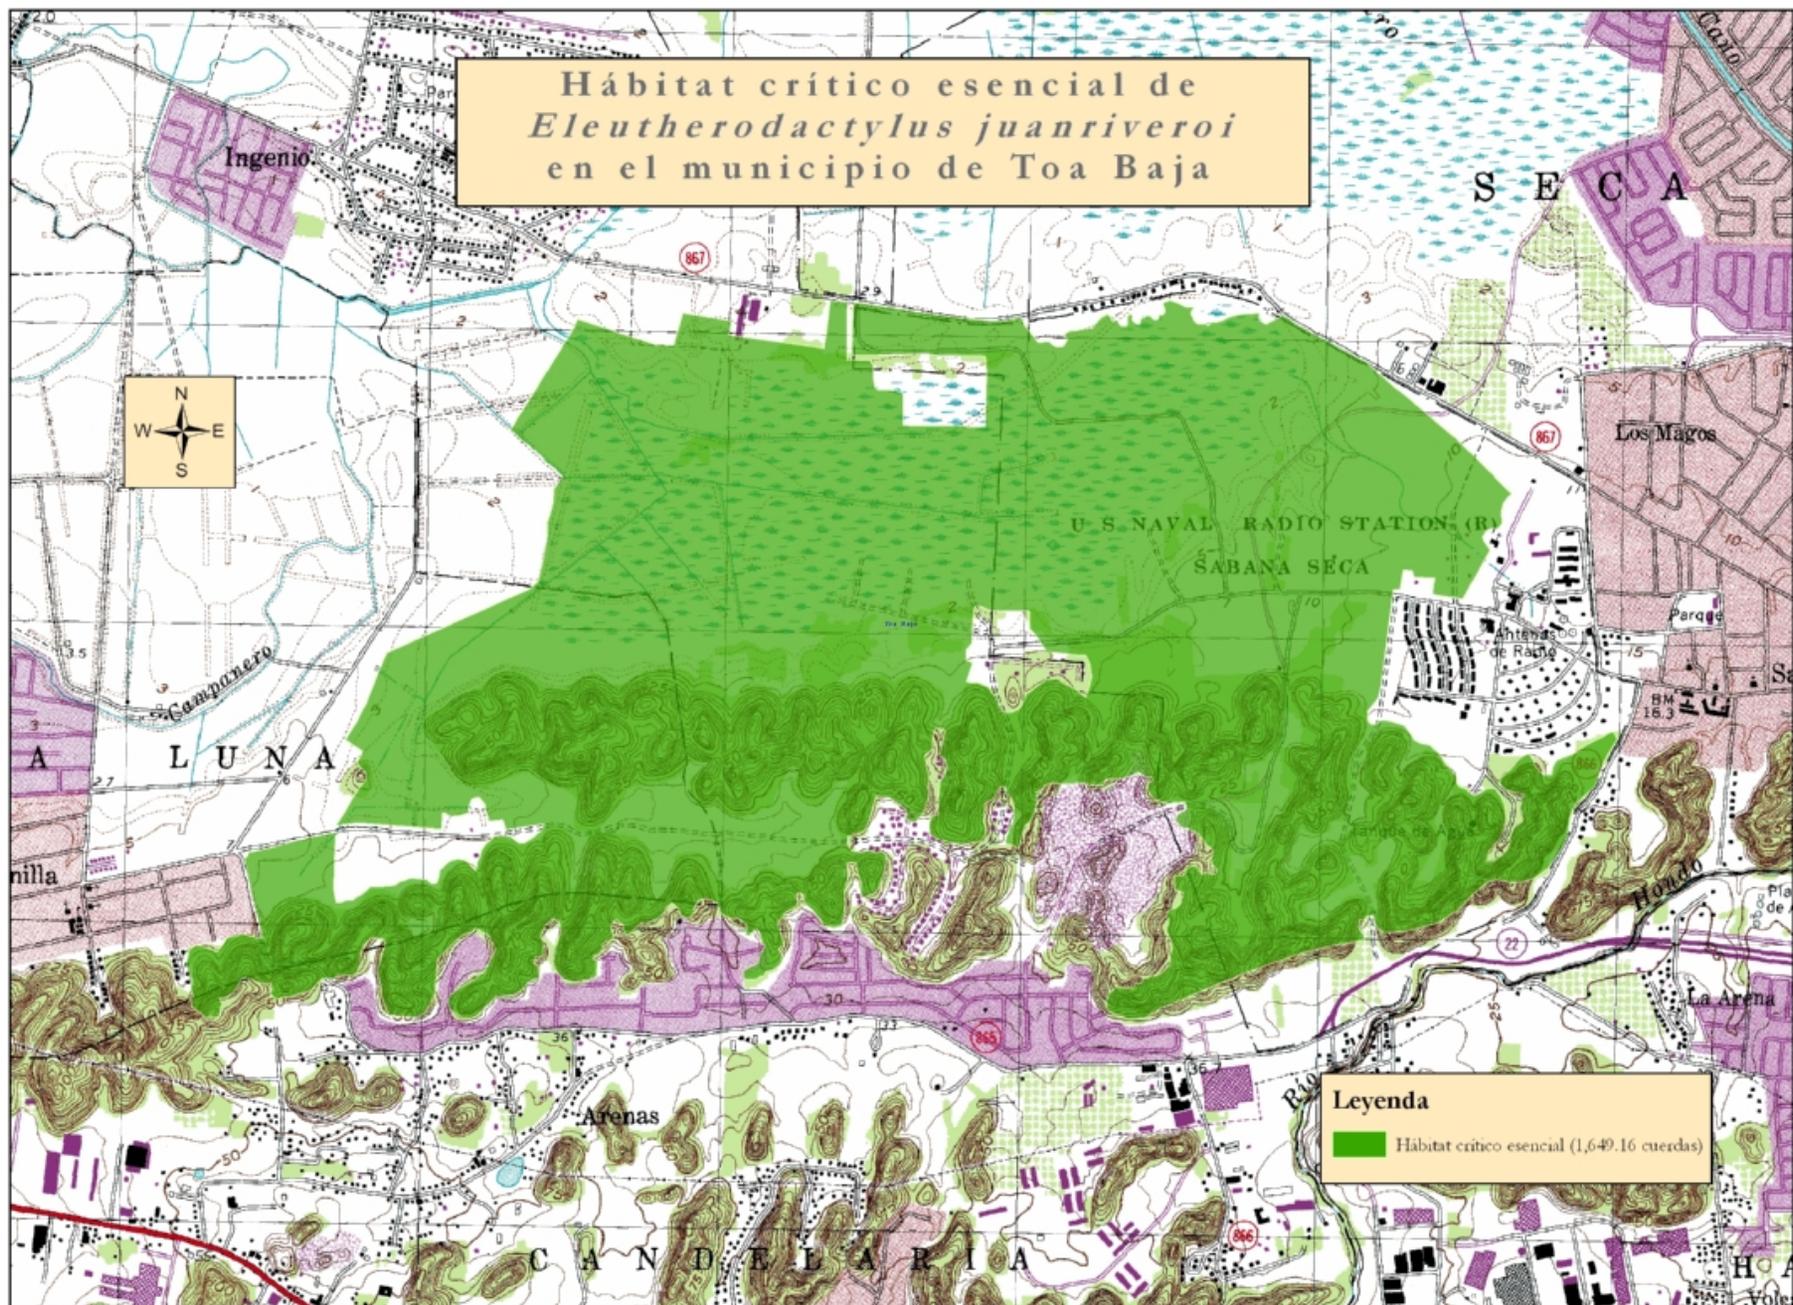
Figure 1: Habitat for Coquí Llanero (*Eleutherodactylus juanriveroi*) in Toa Baja as identified by DNER.

The Essential Critical Habitat area as delimited by DNER is presented in **Figure 1**. It includes two principal types of habitat.

- Wetlands on the Río de la Plata floodplain (474 cuerdas), an area where the species is known to reproduce, generally occupies the northwestern portion of the Essential Critical Habitat area; and
- Additional areas (1,195 cuerdas) which also include some wetlands, relatively level upland areas, and steep limestone haystack hills (mogotes).

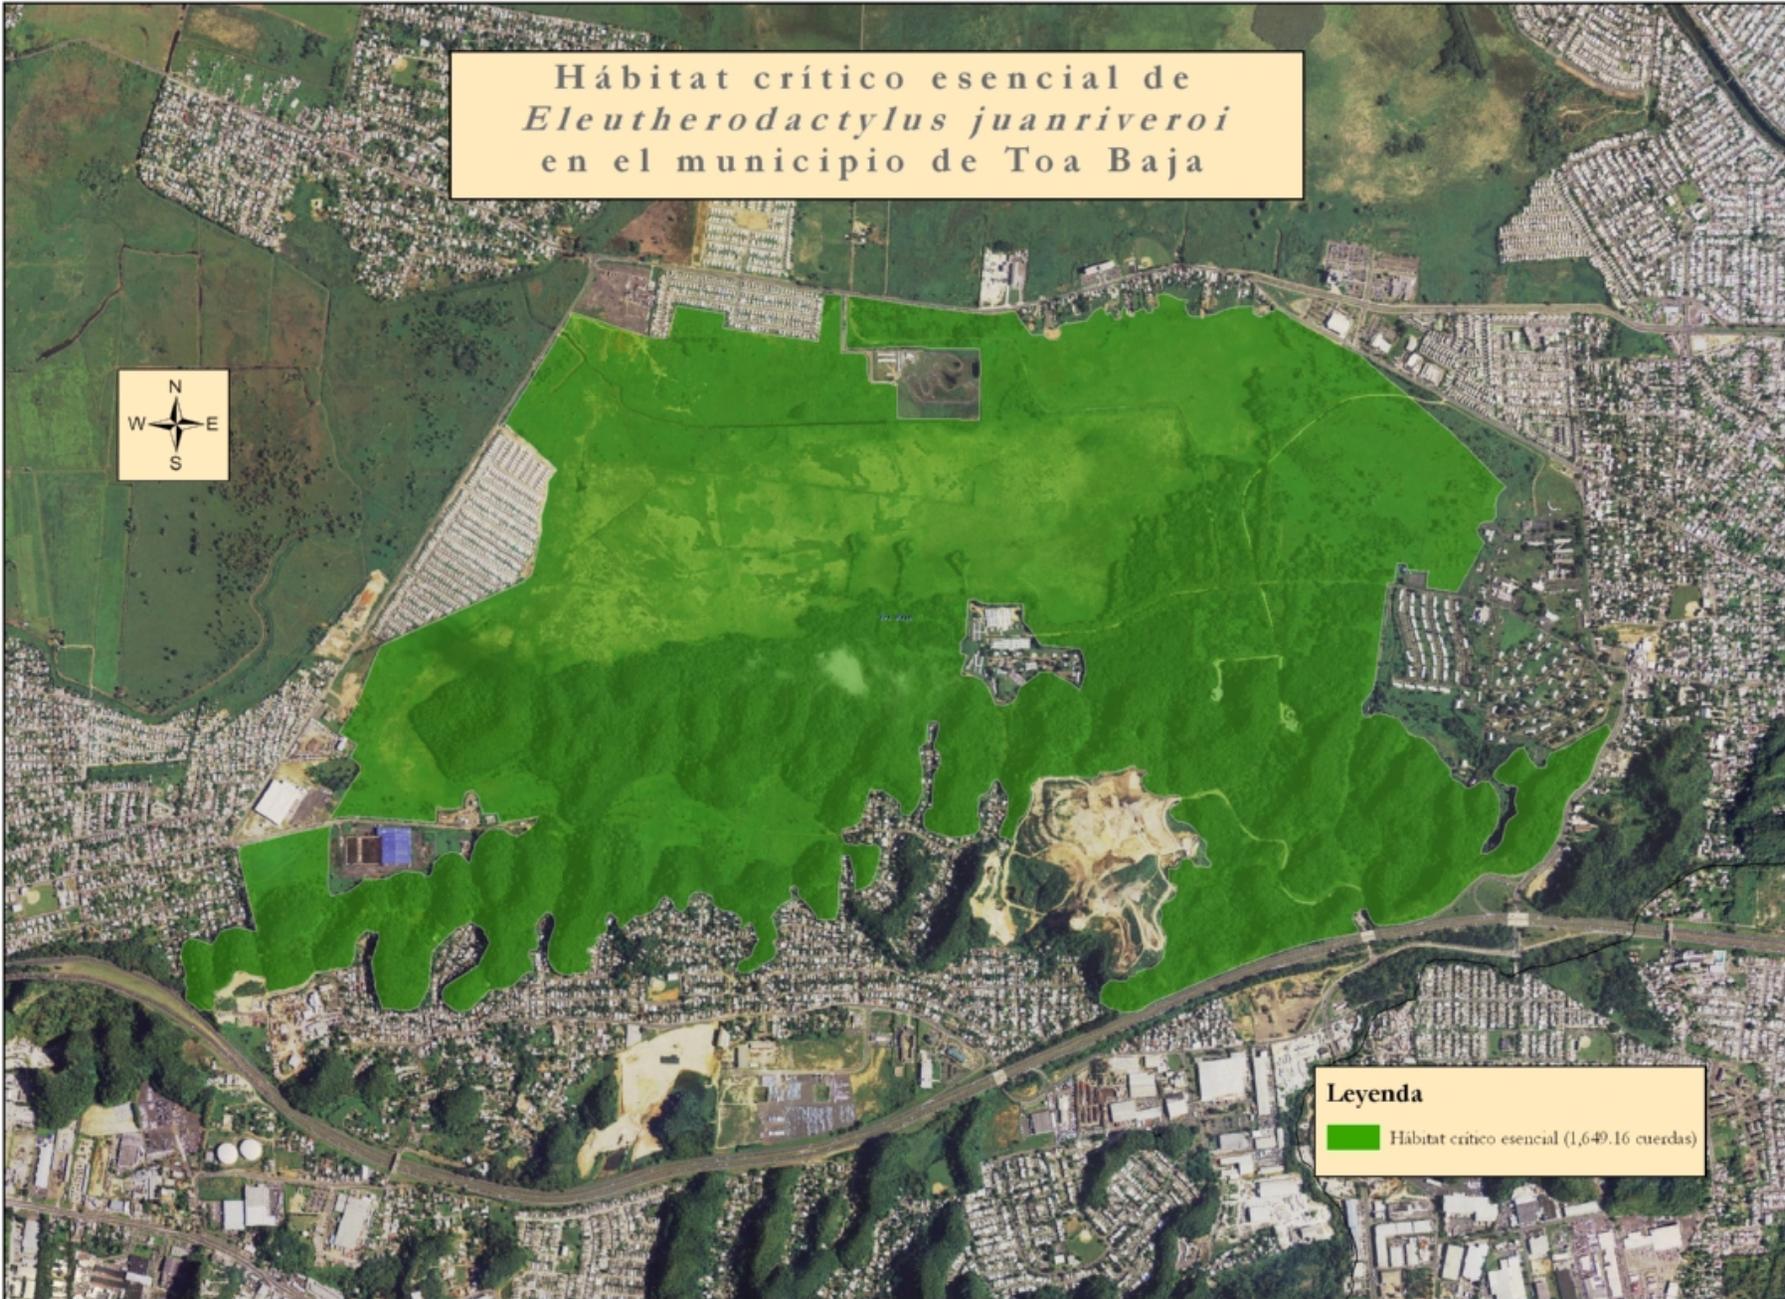
Figure 2: Coquí Llanero habitat on aerial photo as identified by DNER.

The habitat area has also been outlined on a recent aerial photo, as shown in **Figure 2**. To the west this habitat is circumscribed by a recent housing development, which tends to separate the habitat area from the remaining portion of the Río de la Plata floodplain

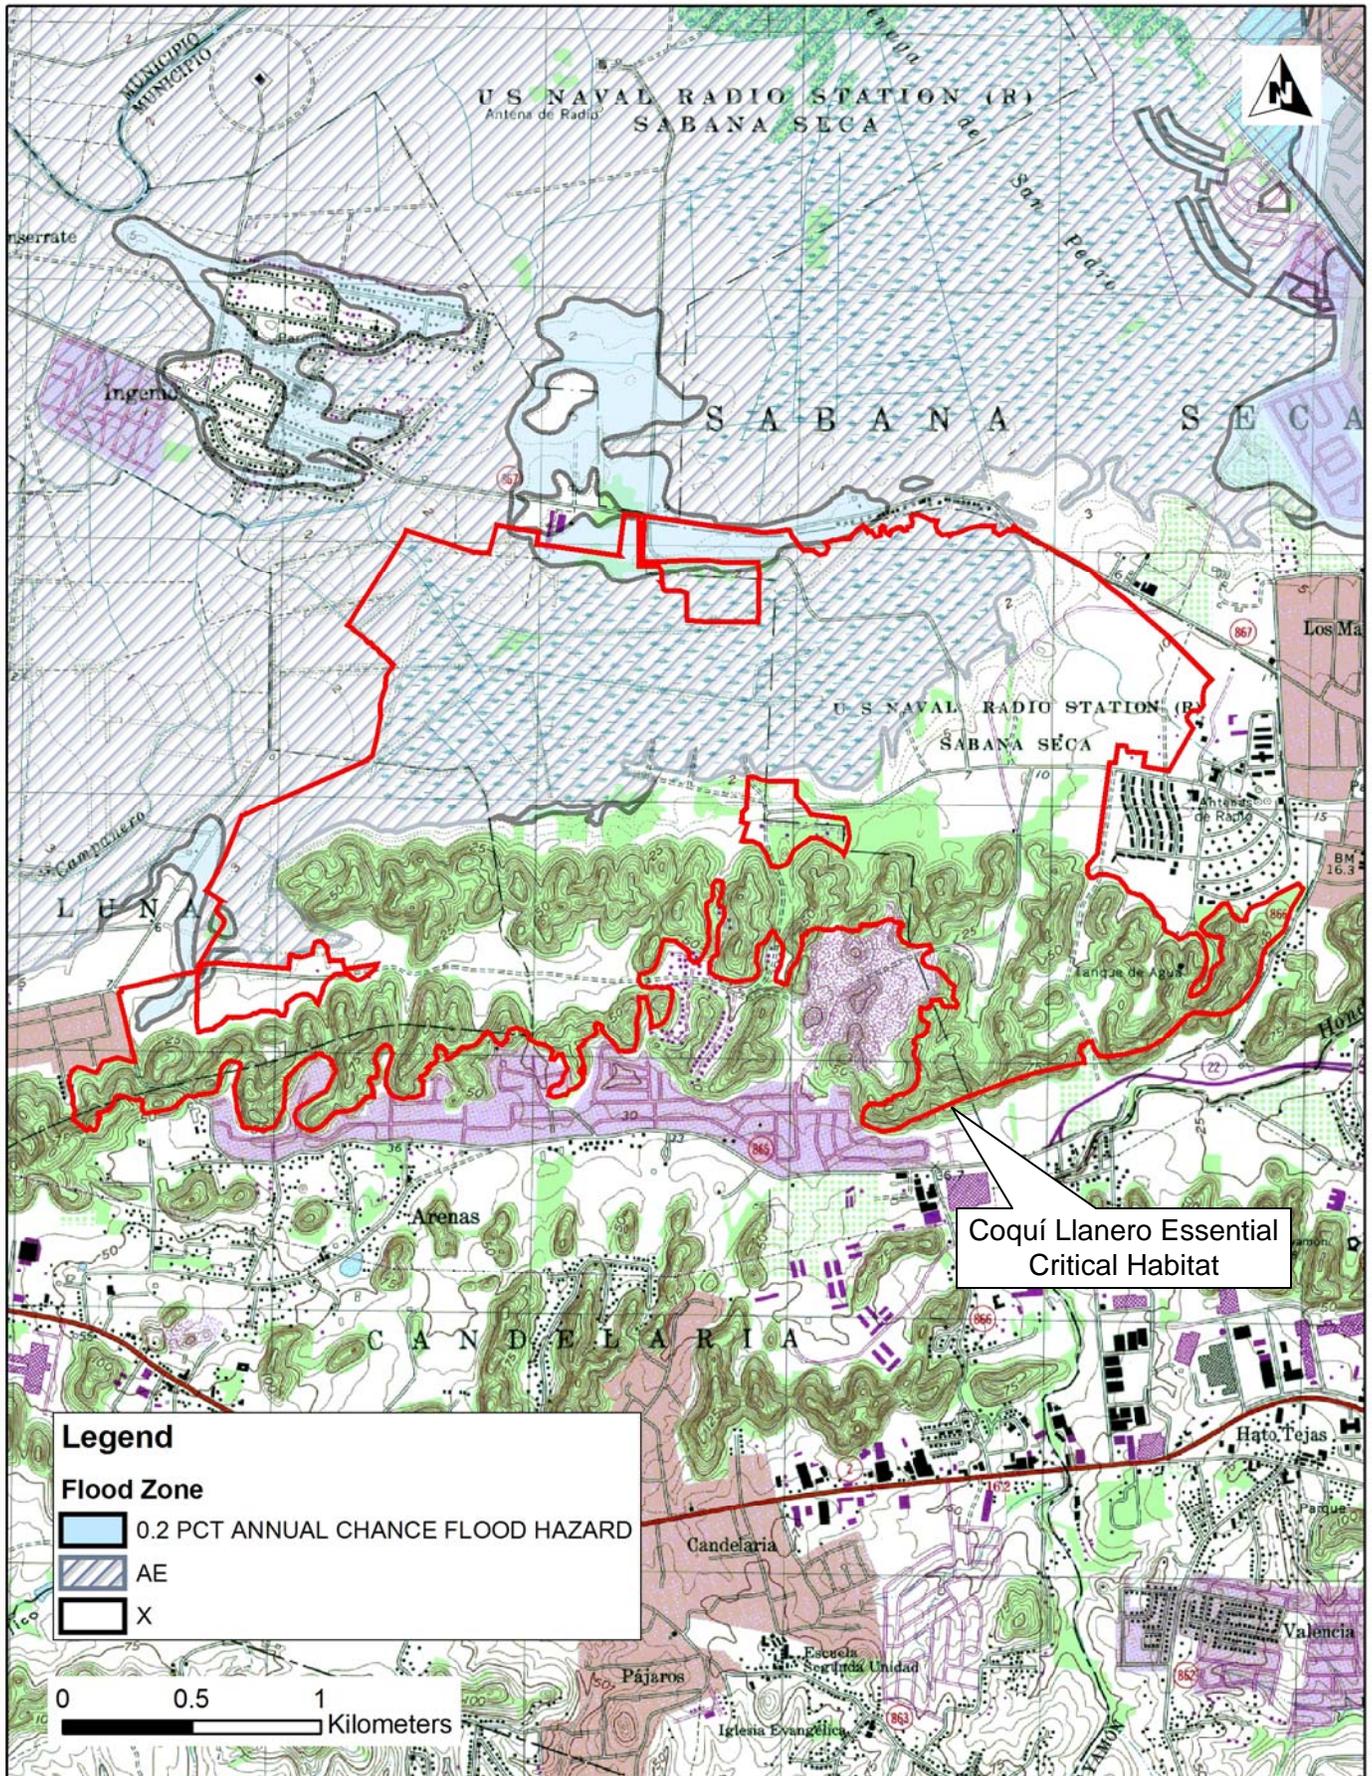
Figure 3: FEMA map showing Coquí Llanero Essential Habitat.

- Wetland areas within the Essential Critical Habitat area may be affected by overflow from Río de la Plata. The FEMA map for the area (**Figure 3**) indicates that wetlands in the northwestern area of the Essential Critical Habitat may be inundated by the 100-year flood from Río de la Plata.

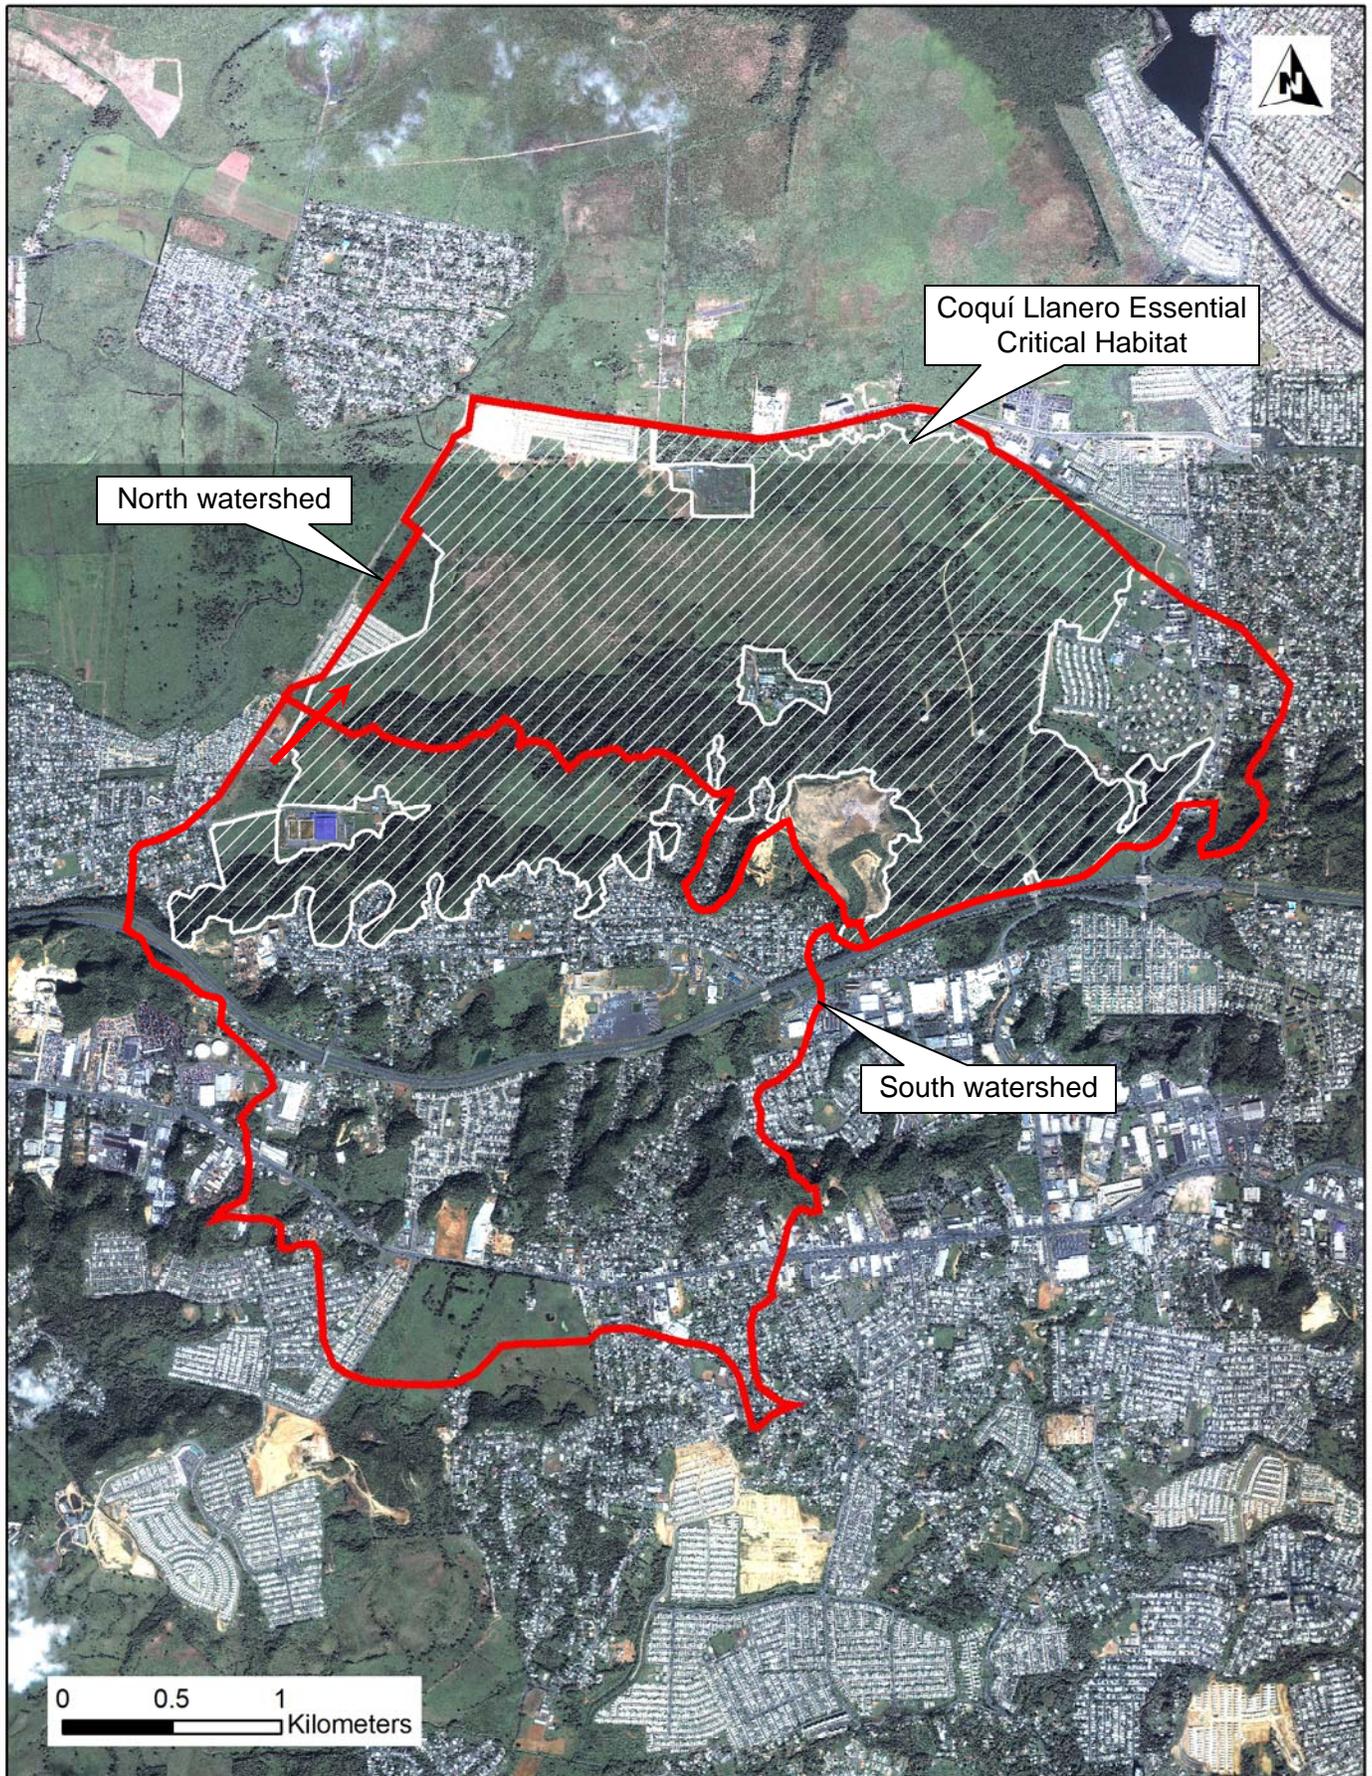
Figure 4: Watersheds contributing to the Coquí Llanero habitat.

1. The **NORTH WATERSHED** is delimited in **Figure 4** and **Figure 5**. It receives runoff from the following directions: (1) from the south it may receive both surface and shallow sub-surface runoff from the mogotes; (2) from the east it receives runoff from the developed portion of the naval communications station; (3) from the north it receives runoff from the adjacent small community along highway PR-867, the highway, and small businesses including the go-kart racing track; and (4) from the west it receives runoff

2. The **SOUTH WATERSHED** receives runoff from limestone topography and drains through a dug canal and into the North Watershed. It is delimited in **Figure 4** and **Figure 5**.

During smaller rainfall events, the drainage within this watershed will discharge primarily to sinkholes and runoff will not be generated from the entire watershed area. However, during extreme rainfall and flooding events the watershed which may contribute runoff to this area is very large and is delimited in **Figure 4** and **Figure 5**. Personnel of our office have observed that surface runoff from the south side of PR-22 entered the Critical Habitat area as a result of rains that occurred during the week of October 10, 2005.

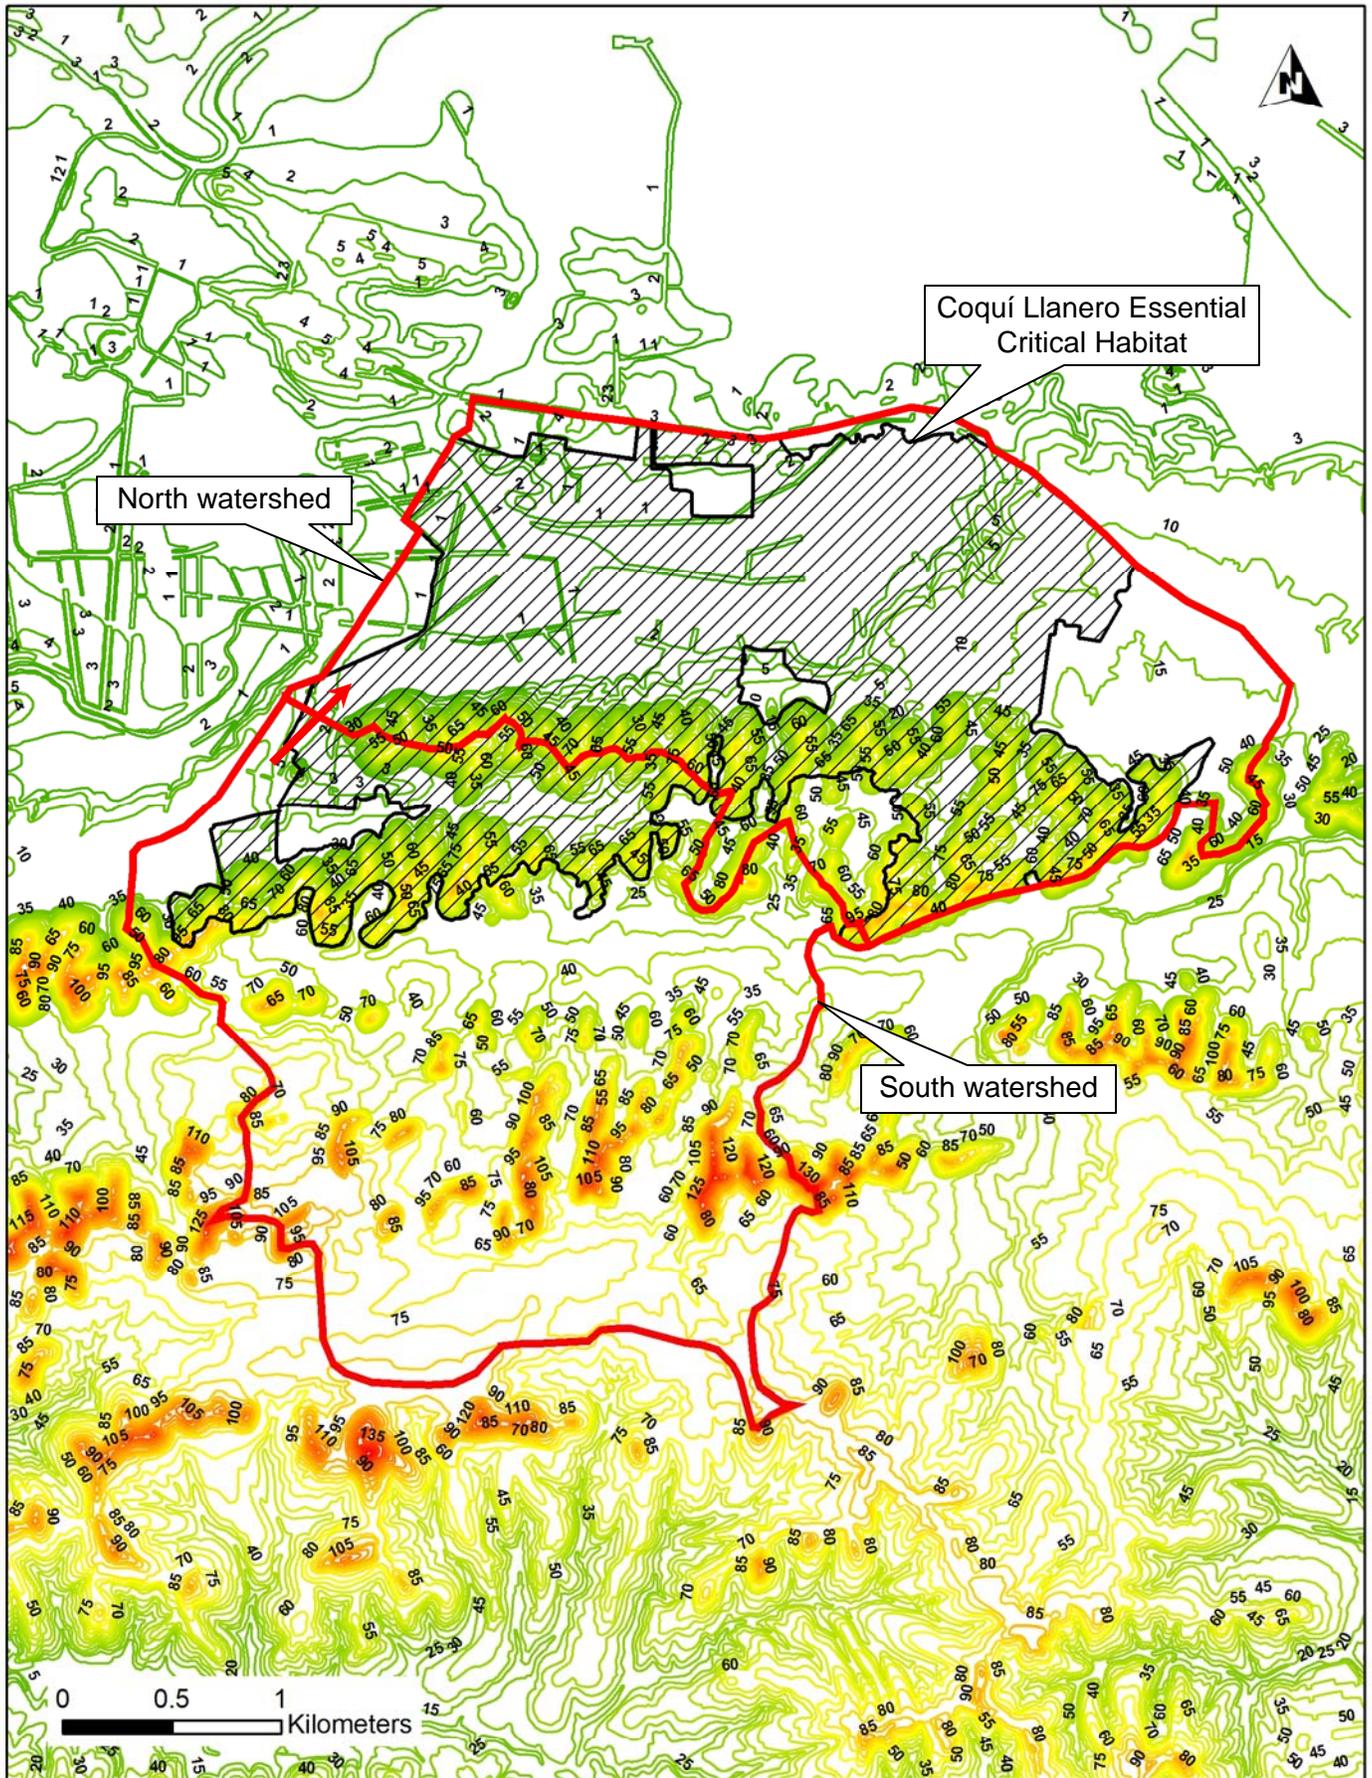
Figure 5: Topographic features of the watershed contributing to the Coquí Llanero habitat.

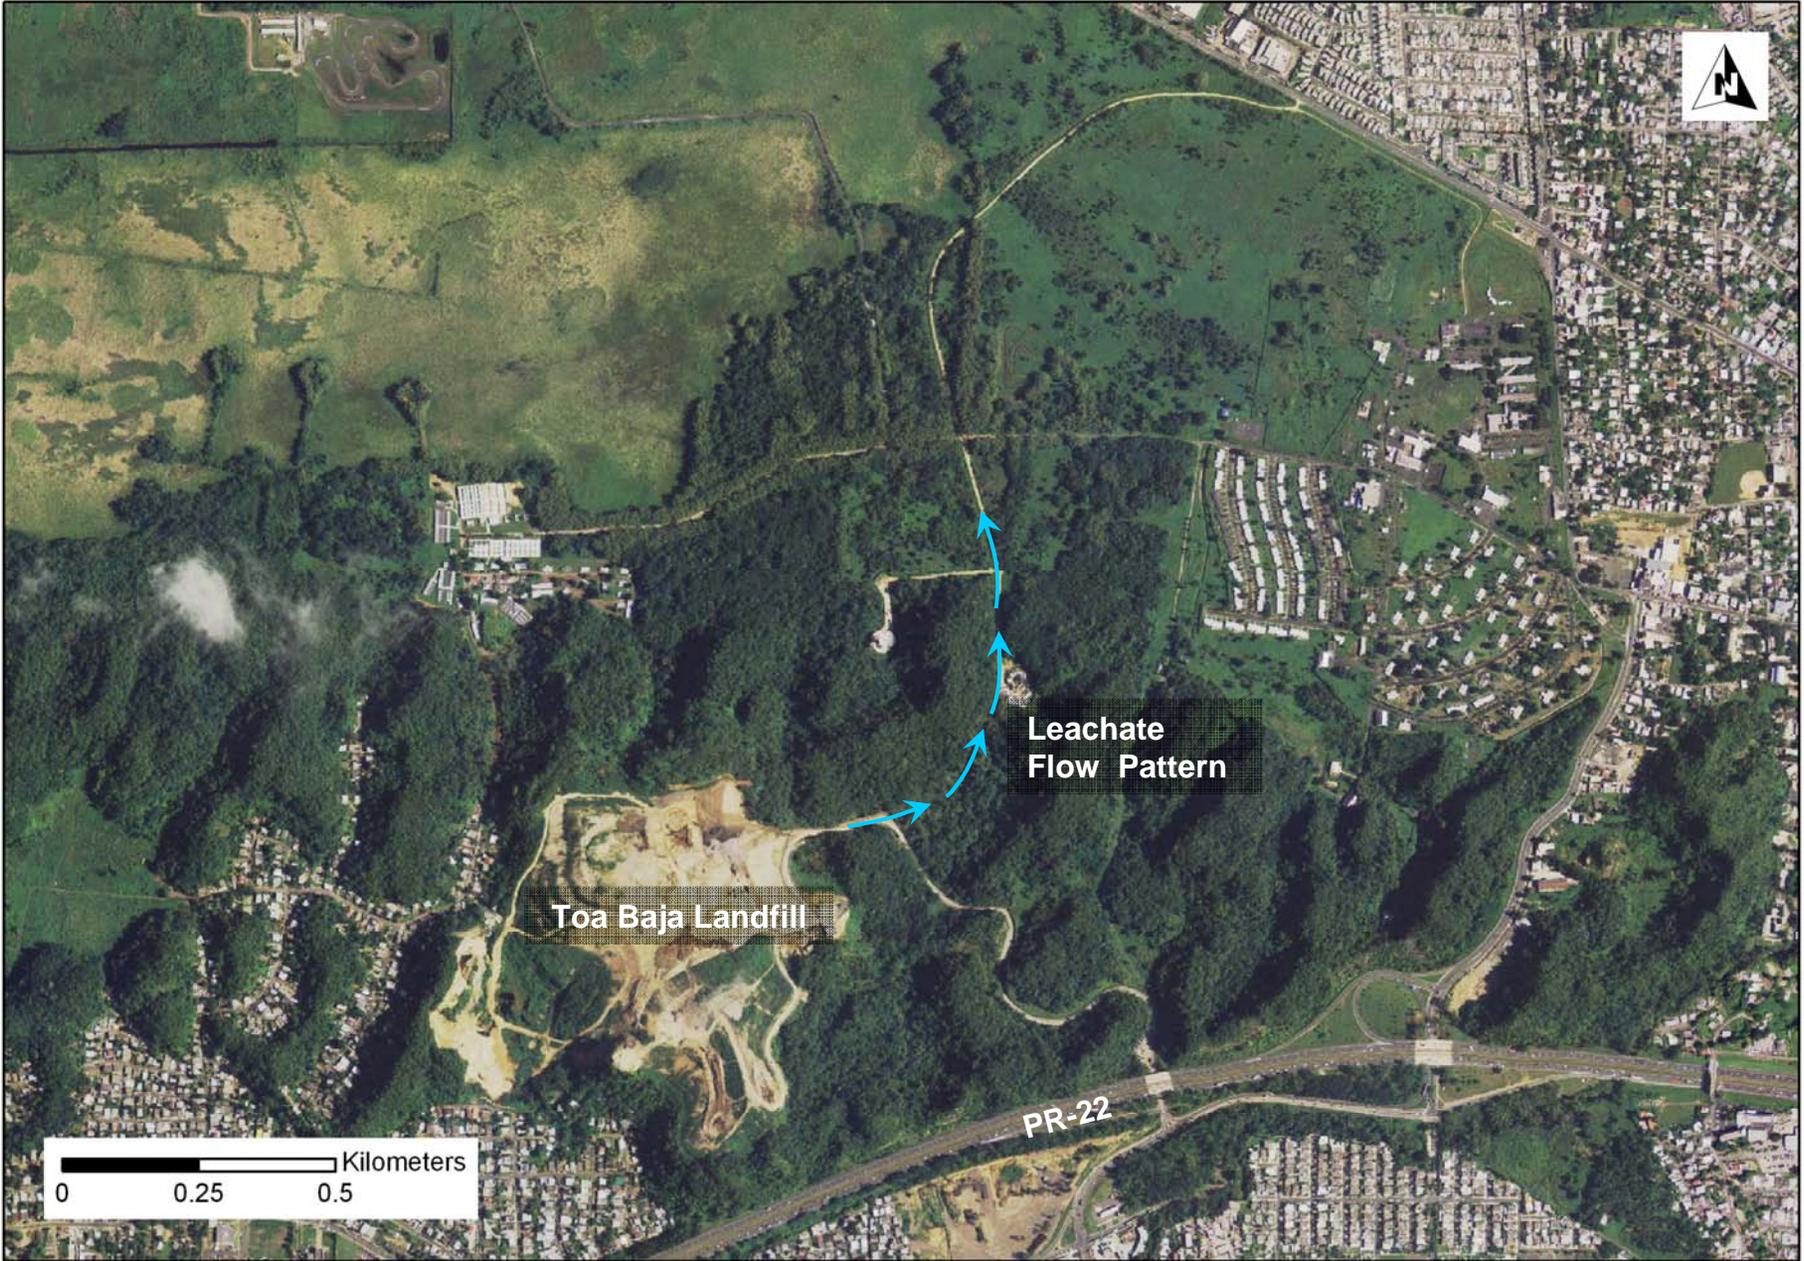
Figure 6: Toa Baja landfill leachate flow patterns.

Field inspection on June 20, 2007 determined that this watershed receives leachate from the Toa Baja Municipal Landfill, via drainage along the perimeter fence road on the Naval Station site. The area where this drainage was observed is shown in **Figure 6**. This problem is known to regulatory agencies but we did not investigate the status of any remedial actions.

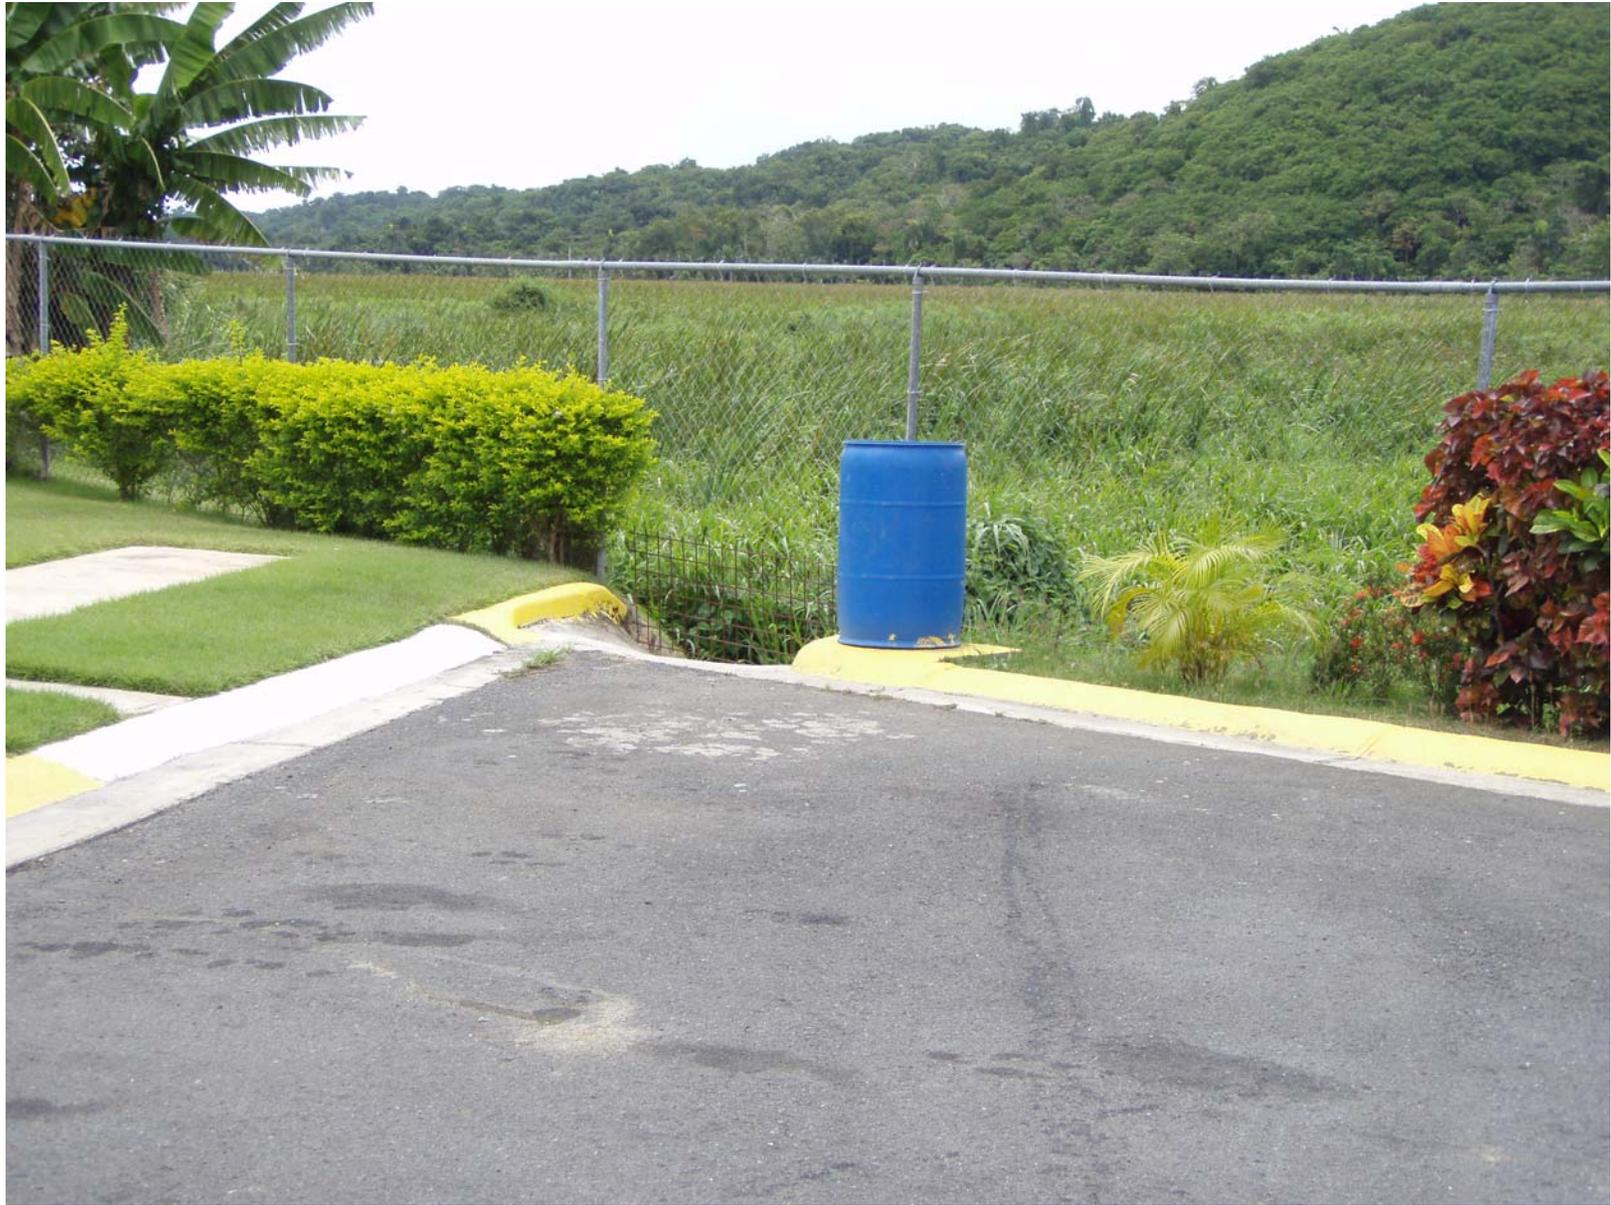
Figure 7(A): Urb. Brisas de Campanero, surface drainage into Essential Critical Habitat wetland.

from a portion of the exiting urban developments bordering the Brisas de Campanera urbanization (**Figure 7A**). This area also receives all runoff from the South Watershed via the drainage canal depicted in **Figure 4** and **Figure 5**, and which runs along the east side of the Brisas de Campanera development. A photograph of the channel which conveys runoff into the North Watershed area of the Essential Critical Habitat area is shown in **Figure 7B**. See **Figure 7C** for photos location.

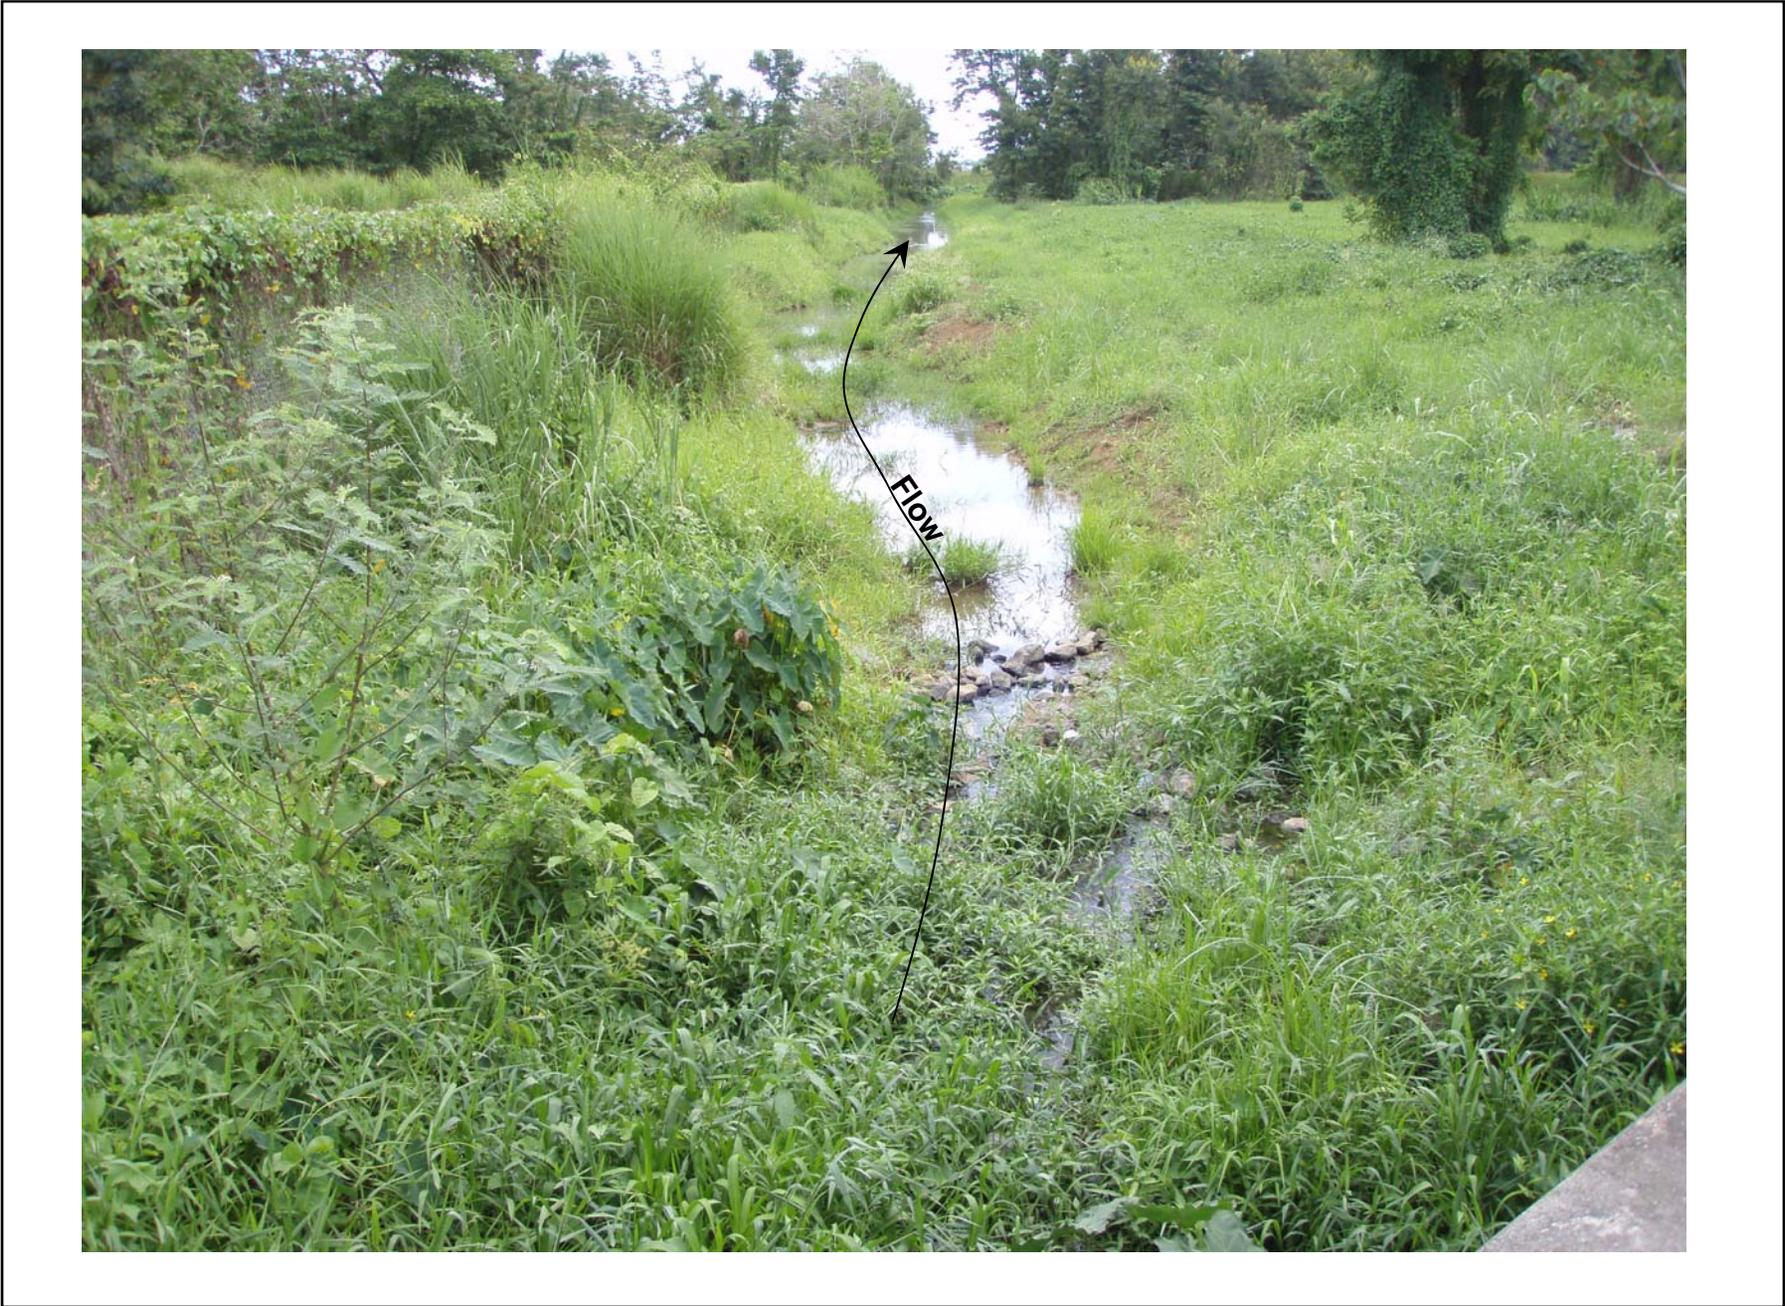
Figure 7(B): Drainage channel which conveys flow from South watershed into North watershed (location of arrow in Figures 4 and 5).
